# HYUNDAI Technical Service Bulletin

Group	ENGINE MECHANICAL
Number	06-01-015
Date	DECEMBER, 2006
Model	2007 AZERA

Subject  
**CAMPAIGN T33 -  
 AZERA OIL CONTROL VALVE INSPECTION AND / OR  
 REPLACEMENT**

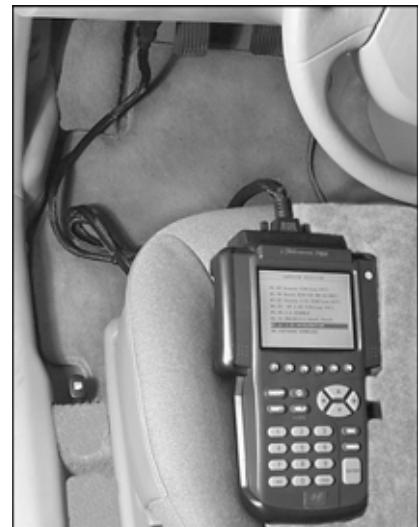
1. Place the shift lever in the "P" or "N" position and start the engine.
2. Connect a Hi-Scan Pro to the DLC connector.
