HYUNDAI Technical Service Bulletin

Group	CAMPAIGN
Number	07-01-002
Date	JANUARY, 2007
Model	AZERA (TG)

Subject
**REAR DOOR WAIST LINE MOLDING REPLACEMENT
 (SERVICE CAMPAIGN T35)**

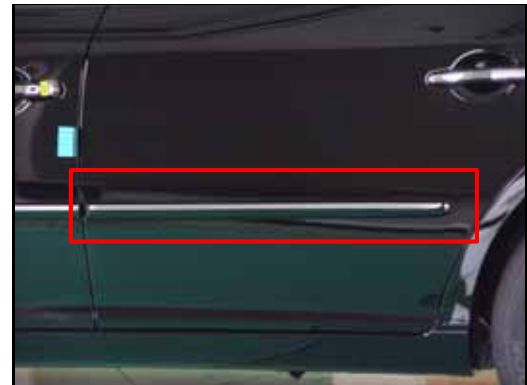
On some Azera vehicles, the stainless steel strip (A) on the rear waist line moldings (B) may separate. This bulletin provides the procedure to replace the rear door waist line moldings with revised parts.
