SUBJECT: Recall Campaign 092 - Stop Lamp Switch Replacement - TSB# 09-01-018

HYUNDAI Technical Service Bulletin

Group		CAMPAIGN
		Number		09-01-018
Subject		Date		JUNE, 2009
		Model		SEE BELOW
STOP LAMP SWITCH REPLACEMENT (CAMPAIGN 092)				
CIRCULATE TO:	<input type="checkbox"/> GENERAL MANAGER	<input checked="" type="checkbox"/> PARTS MANAGER	<input checked="" type="checkbox"/> TECHNICIAN	
<input checked="" type="checkbox"/> SERVICE ADVISOR	<input checked="" type="checkbox"/> SERVICE MANAGER	<input checked="" type="checkbox"/> WARRANTY MGR	<input type="checkbox"/> SALES MANAGER

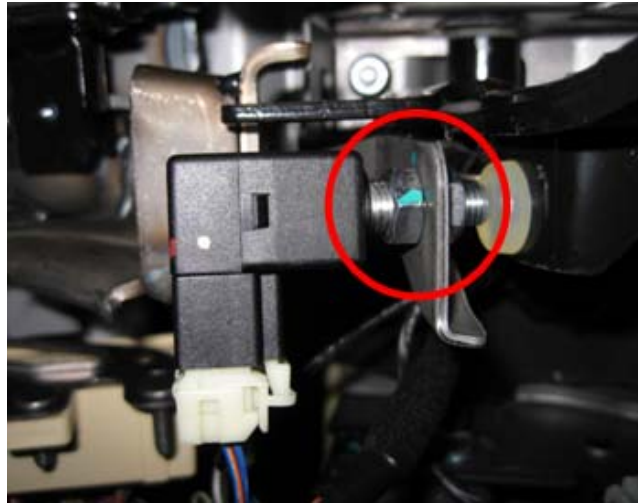
"The stop lamp switch in the affected vehicles may malfunction. A malfunctioning stop lamp switch may cause the brake lights to not illuminate when the brake pedal is depressed or may cause the brake lights to remain illuminated when the brake pedal is released. A stop lamp switch malfunction may affect the operation of the brake-transmission shift interlock feature so the transmission shifter would not be able to be shifted out of Park position. It may also cause the electronic stability control (ESC) malfunction light to illuminate, and it may not deactivate the cruise control when the brake pedal is depressed. These malfunctions may lead to a crash.

4. Loosen lock nut and remove the stop lamp switch from its mount. Disconnect the connector and remove the stop lamp switch from the vehicle.
