# HYUNDAI Technical Service Bulletin

Group	CAMPAIGN
Number	10-01-006
Date	JANUARY, 2010
Model	2008-09 SANTA FE 2008-09 VERACRUZ, AZERA

Subject	<b>NAVIGATION REPROGRAMMING SERVICE CAMPAIGN T86</b>
---------	--

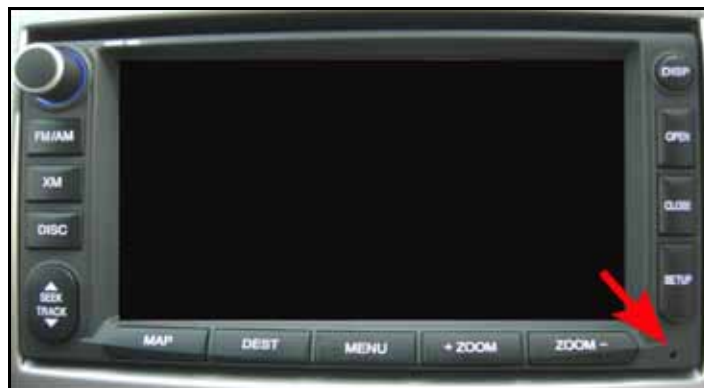
**NOTE: If the navigation screen is blank or locks up, press the RESET button at the bottom right corner of the unit three times to attempt to restart the unit. If the unit restarts, proceed with the reprogramming. If the unit does not restart, it will need to be replaced. Replacement units have the new software program installed.**
