# HYUNDAI Technical Service Bulletin

| Number | 09-01-003 |
| Model | 2007 SONATA (NF) |

Subject  
**2007MY SONATA SUN VISOR REPLACEMENT  
 (SERVICE CAMPAIGN T74)**

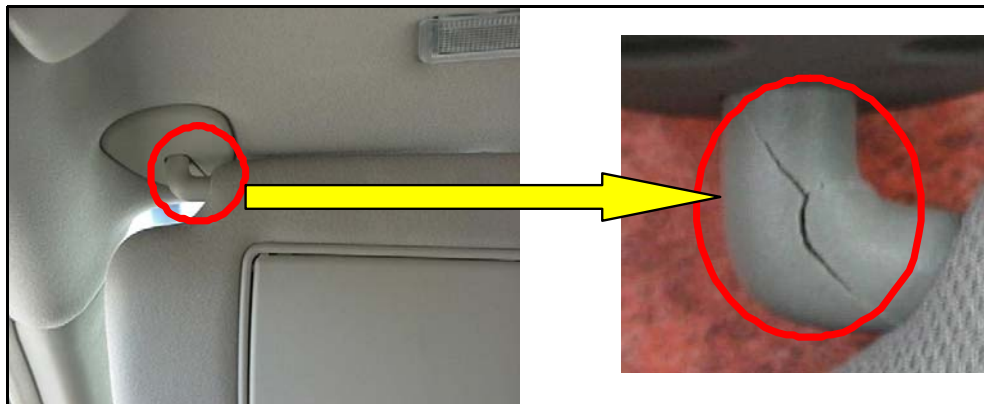
- Symptom/Condition  
 On some 2007MY Sonata (NF) vehicles, the sun visor pivot arm may crack or may not hold the desired position.

- Countermeasure  
 Replace both left and right sun visor assemblies for customer satisfaction.
