HYUNDAI Technical Service Bulletin

Group	CAMPAIGN
Number	10-01-021
Date	MAY, 2010
Model	2010MY GENESIS COUPE (BK)

Subject **3.8L AUTOMATIC TRANSMISSION SHIFT CABLE END-ROD BOOT REPLACEMENT (SERVICE CAMPAIGN TB5)**

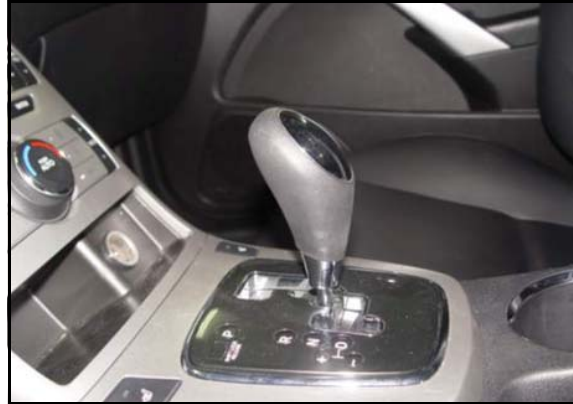
1. Drive the vehicle onto a lift and place the shift lever in "N" position. Lift up the vehicle.

CAUTION: Shift lever must remain in "N" position throughout this procedure

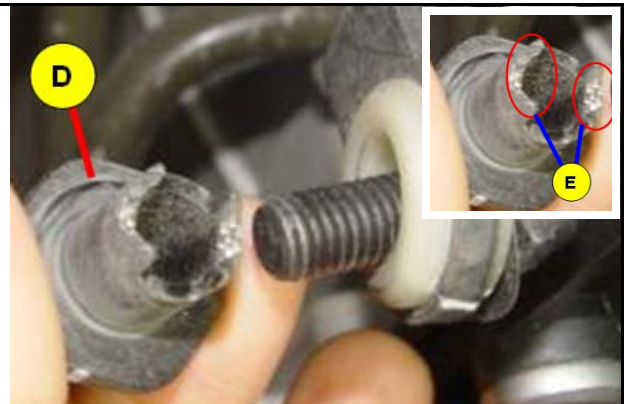
4. Remove the cable end-rod sleeve (D).

CAUTION: When reinstalling the shift cable end-rod sleeve (D), position the "U" shaped cut ends (E) horizontally.

IMPORTANT: Mark the position of the shift cable where it passes through the hole in the bolt prior to removing the bolt. This process will help prevent misadjustment of the cable during reassembly.

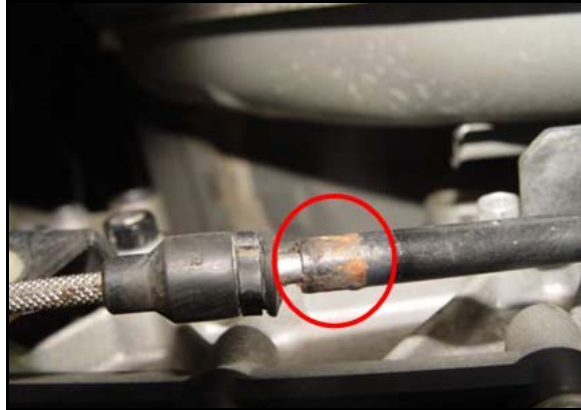
7. Clean rust and dirt off the shift cable end-rod with WD-40.

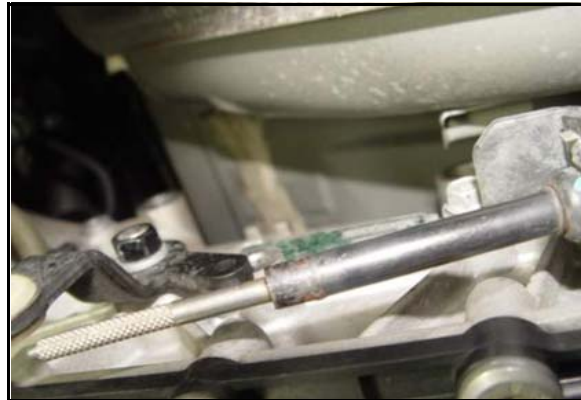
- Photo shows the cable end-rod boot removed and the cable end-rod after it has been cleaned of rust and dirt.

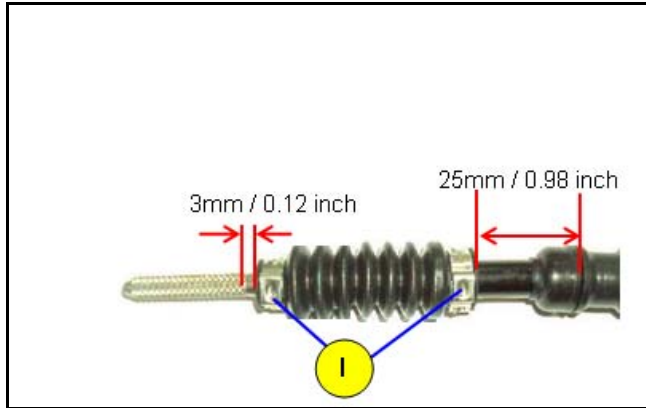
9. Position the cable end-rod boot as indicated in the photo. The distance from the front end of the boot to the cable knurling should be about 3mm (0.12 inch) and the

distance from the rear end of the boot to the shift cable bracket about 25mm (0.98inch).

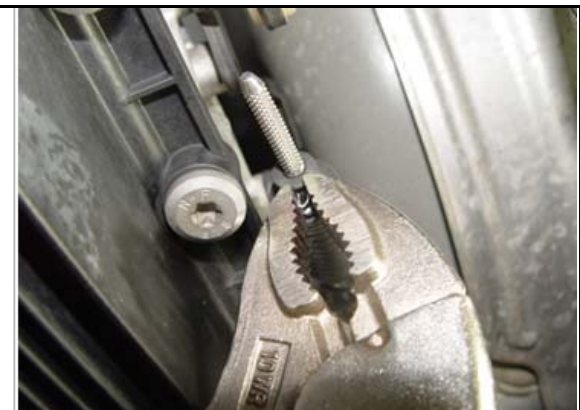
10. Using a crimp plier, clamp both the front and rear clamp ears.

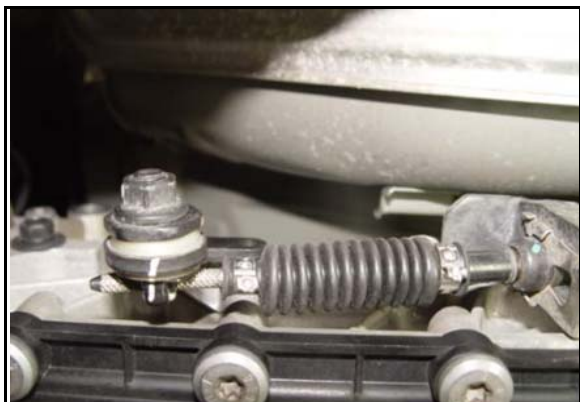
- Photo shows the new boot installed on the shift cable end-rod boot.
