HYUNDAI Technical Service Bulletin

Group	CAMPAIGN
Number	07-01-002
Date	JANUARY, 2007
Model	AZERA (TG)

Subject
**REAR DOOR WAIST LINE MOLDING REPLACEMENT
 (SERVICE CAMPAIGN T35)**

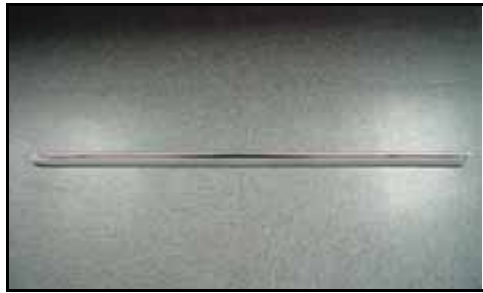
Part Name	Part Number	Picture	Qty
Rear Door Waist Line Molding	87730-3L020 N2 QQH 87730-3L020 EB QQH 87730-3L020 G6 QQH 87730-3L020 B7 QQH 87730-3L020 M9 QQH 87730-3L020 T9 QQH 87730-3L020 Y5 QQH 87730-3L020 F9 QQH 87730-3L020 S7 QQH

NOTE: Refer to the 2-digit PAINT code from the VIN plate located at the lower portion of the driver side B-pillar. Locate the part number with the corresponding paint code in BOLD from the list above. Each kit includes color-code painted waist line molding assemblies for both rear doors.
