SUBJECT: Recall Campaign 092 - Stop Lamp Switch Replacement - TSB# 09-01-018

HYUNDAI Technical Service Bulletin

Group		CAMPAIGN
		Number		09-01-018
Subject		Date		JUNE, 2009
		Model		SEE BELOW
STOP LAMP SWITCH REPLACEMENT (CAMPAIGN 092)				
CIRCULATE TO:	<input type="checkbox"/> GENERAL MANAGER	<input checked="" type="checkbox"/> PARTS MANAGER	<input checked="" type="checkbox"/> TECHNICIAN	
<input checked="" type="checkbox"/> SERVICE ADVISOR	<input checked="" type="checkbox"/> SERVICE MANAGER	<input checked="" type="checkbox"/> WARRANTY MGR	<input type="checkbox"/> SALES MANAGER

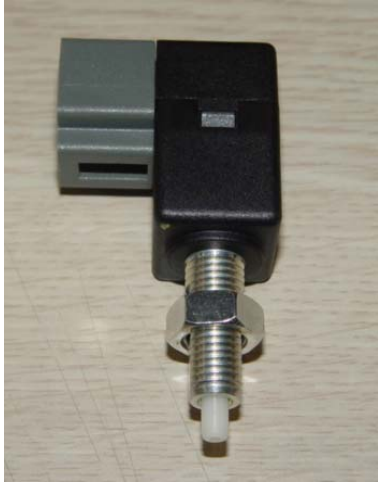
93810-3K000	93810-3K000QQH	Connector body color change: Black (previous) -> Gray (new) For MC, HD, NF/ NFA, TG, JM, EN, and 3.3L CM/ CMA
		93810-38110		
Service Kit - Stop Lamp Switch

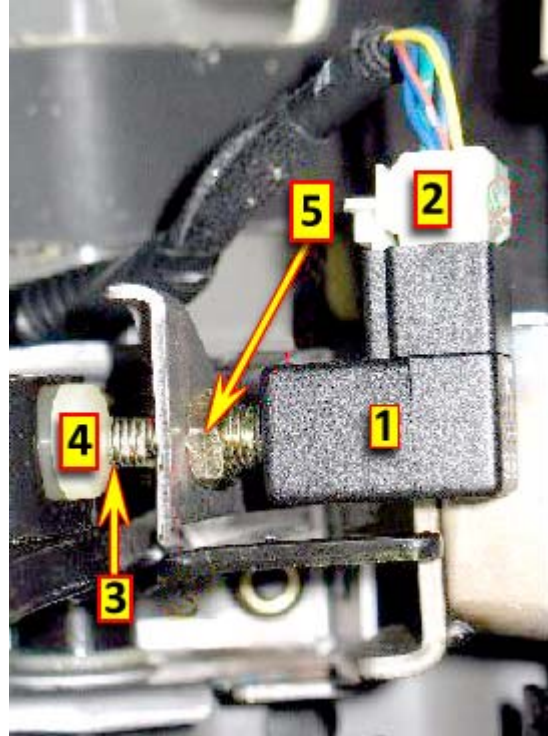
COMPONENTS:

1. Stop Lamp Switch Assembly
2. Stop Lamp Switch Connector
3. Stop Lamp Switch Plunger
4. Brake Pedal Stopper
5. Stop Lamp Switch Lock Nut

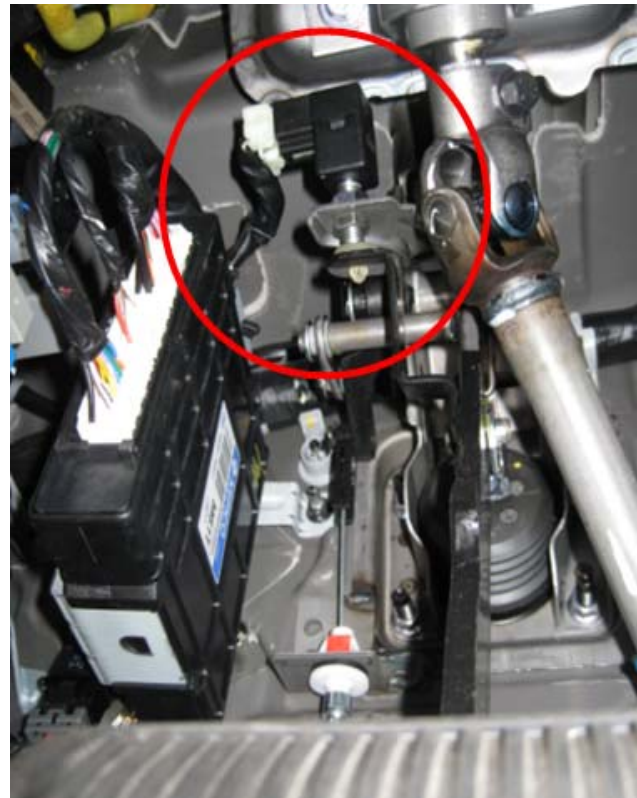
3. Locate the stop lamp switch connected to the brake pedal assembly underneath the dash on the driver side.

4. Loosen lock nut and remove the stop lamp switch from its mount. Disconnect the connector and remove the stop lamp switch from the vehicle.
