HYUNDAI Technical Service Bulletin

Group	CAMPAIGN
Number	09-01-033
Date	NOVEMBER, 2009
Model	GENESIS COUPE (BK)

Subject
MANUAL TRANSMISSION GEAR SHIFT KNOB REPLACEMENT (CAMPAIGN T98)

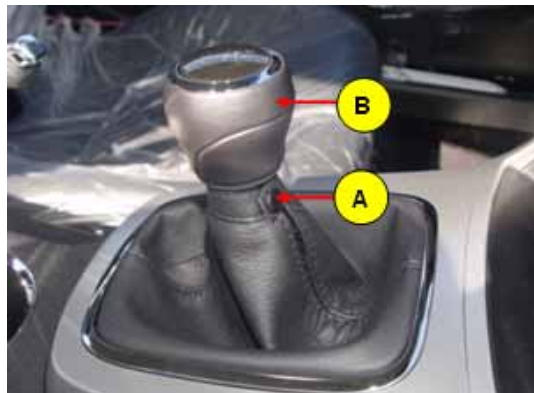
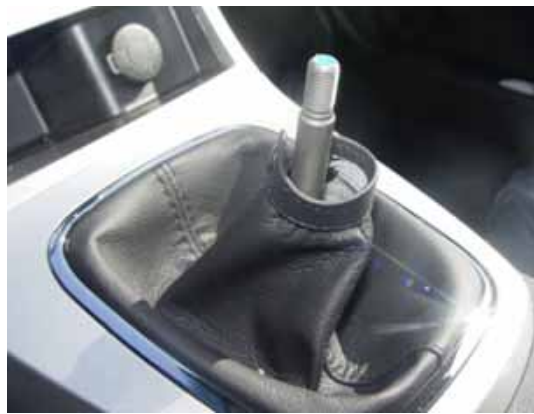
1. Undo the gear shift lever book button (A) and remove the gear shift lever knob (B) by turning it counterclockwise.

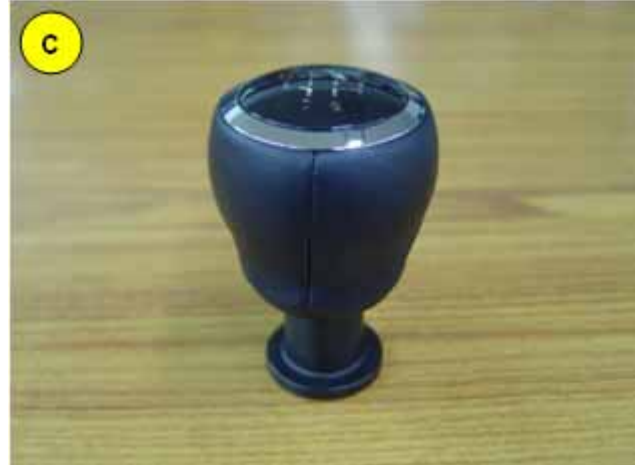
2. Install the new gear shift lever knob (C). Properly align the gear position diagram on the shift knob.
3. Re-button the shift boot.
